AN INNOVATIVE LABORATORY PROJECT TO STUDY
CORROSION THEORY, CORROSION DETECTION AND THE
RESULTING LOSS OF STRUCTURAL STRENGTH DUE TO AN
EXFOLIATION CORROSION ATTACK

Ronald Sterkenburg & Douglas Latia
Purdue University

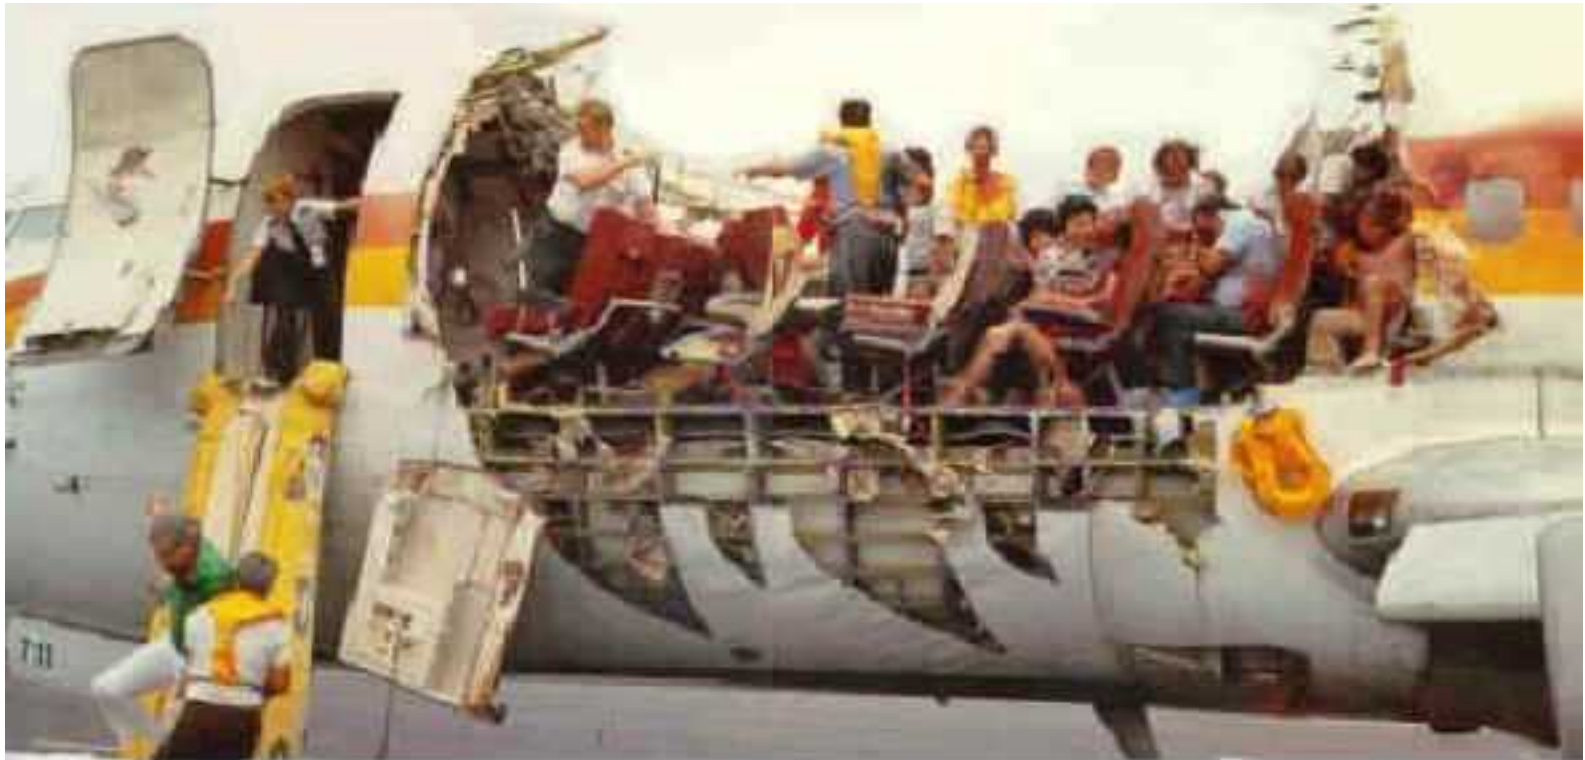
B737 fuselage skin lap joints

- The combination of corrosion, pressurization cycles and knife-edge deep countersinking resulted in fatigue cracks that connected the rivet holes like a zipper.
- National Transportation Safety Board investigation report issued in 1989 attributed the incident to the failure of the operator's maintenance program to detect corrosion damage.

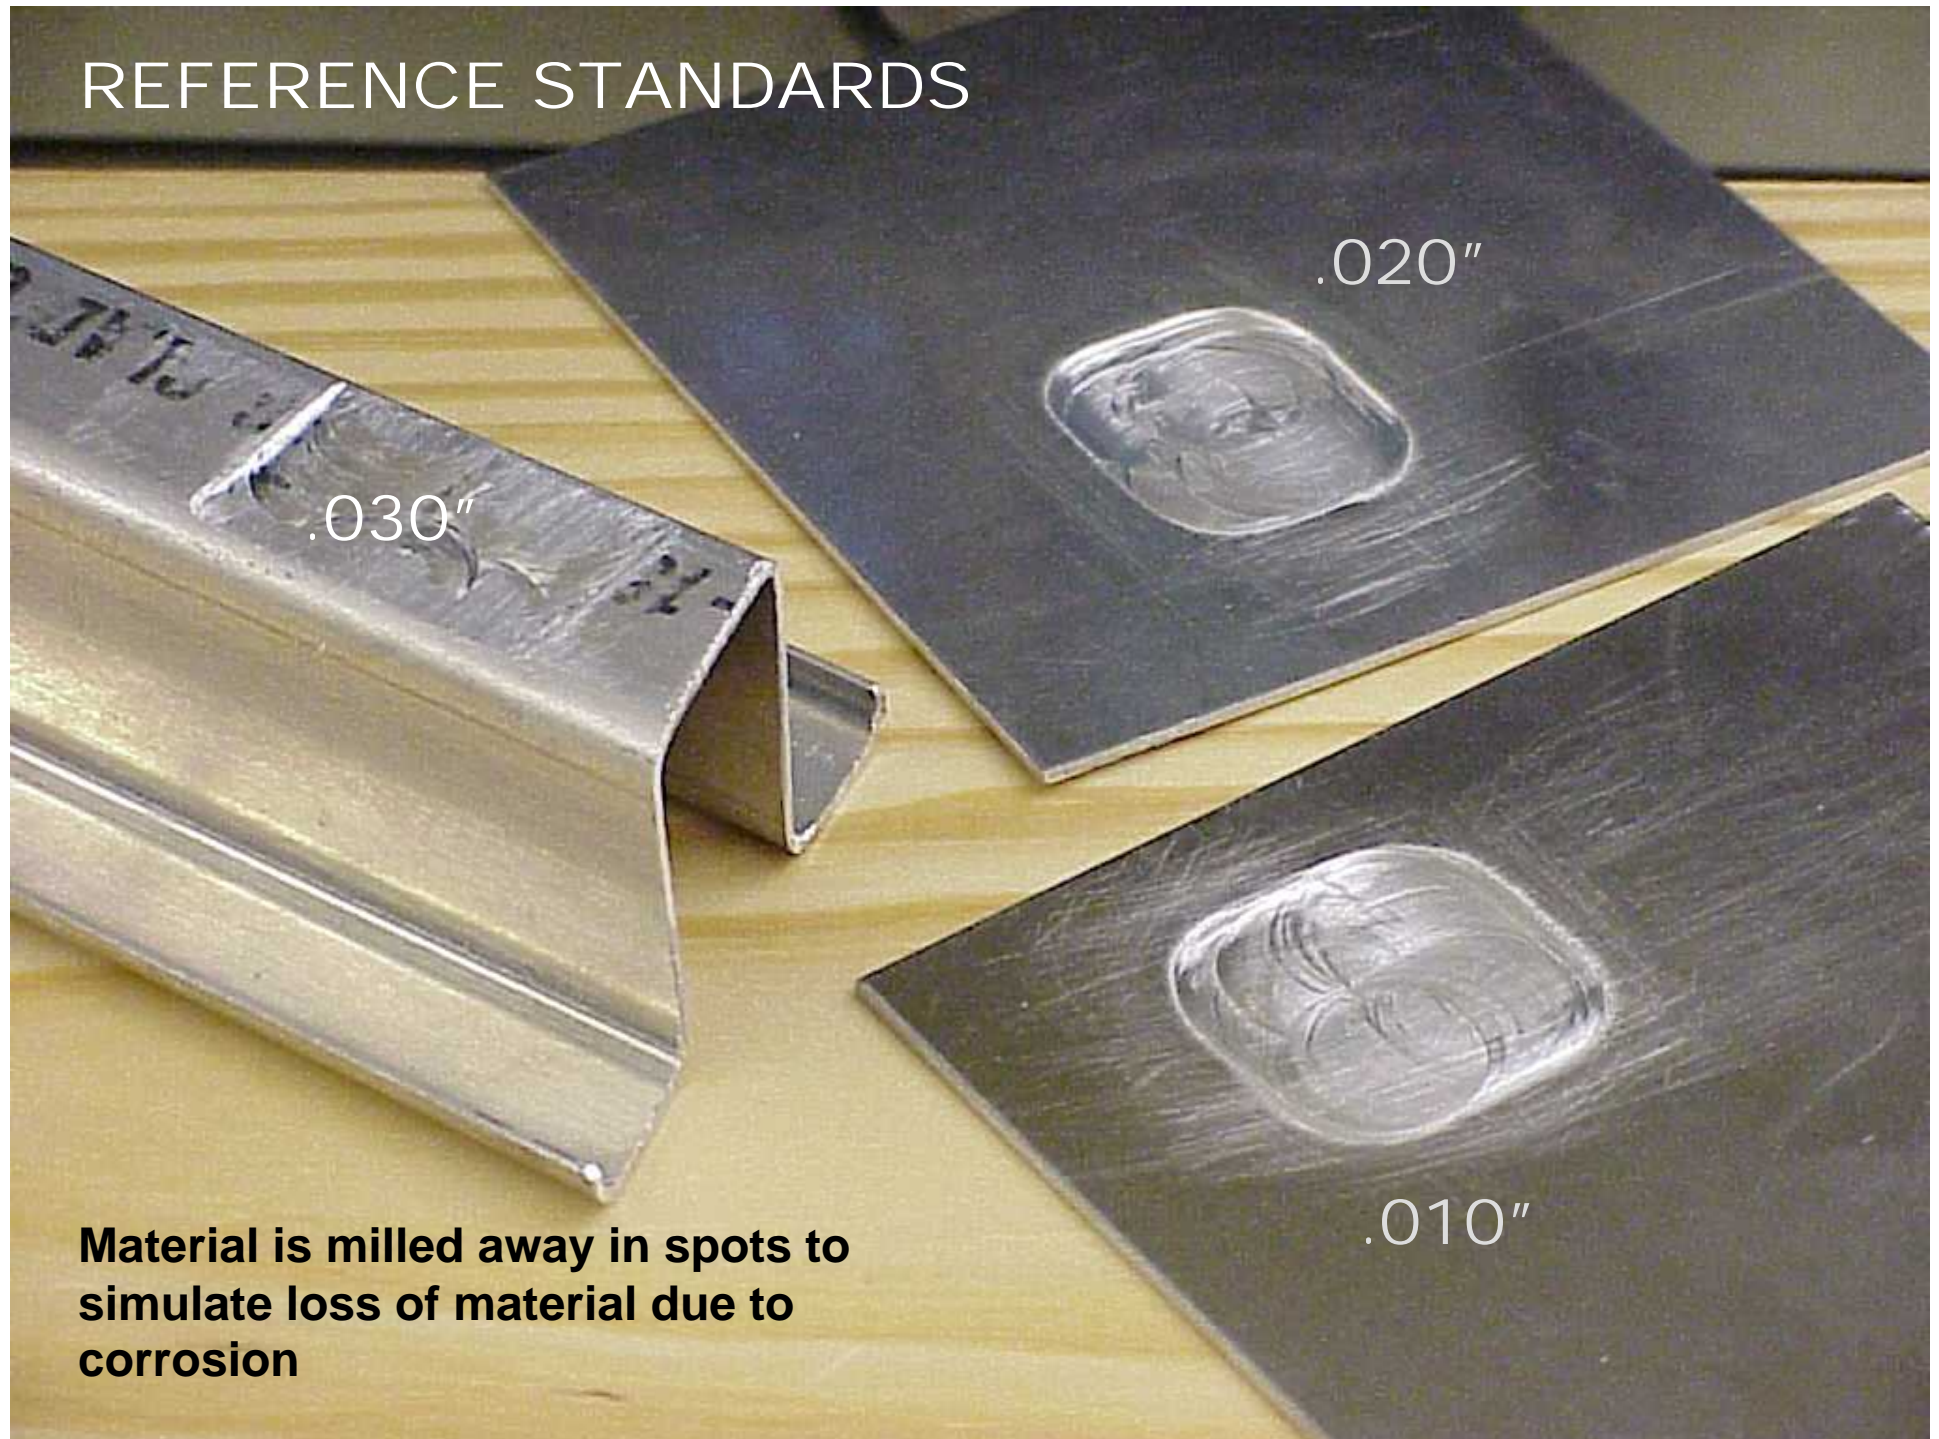
REFERENCE STANDARDS

Material is milled away in spots to simulate loss of material due to corrosion

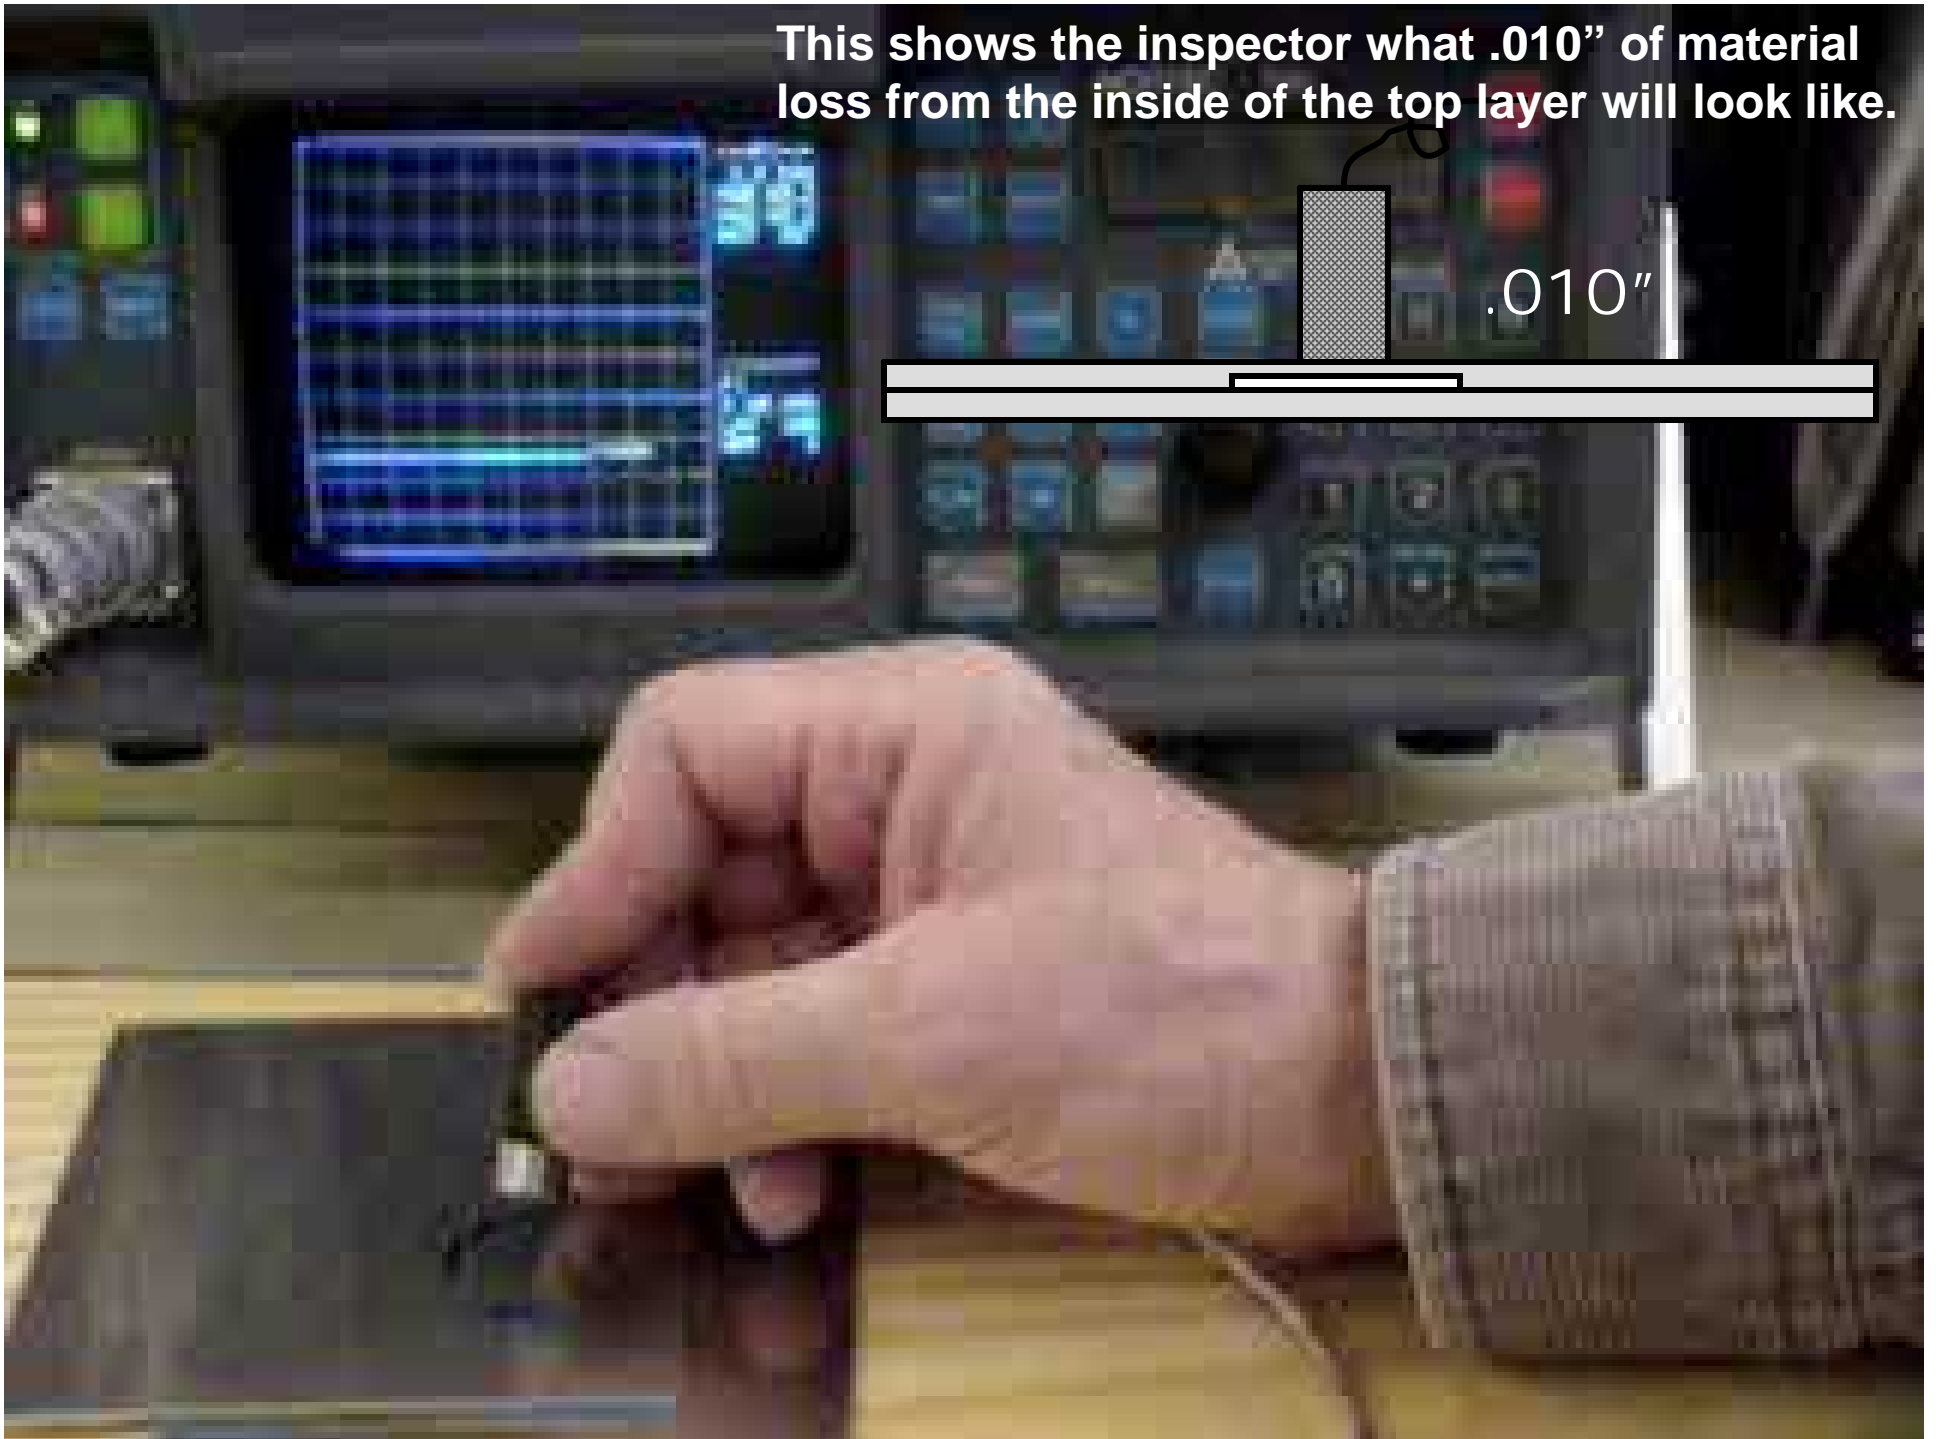
This shows the inspector what .010" of material loss from the inside of the top layer will look like.

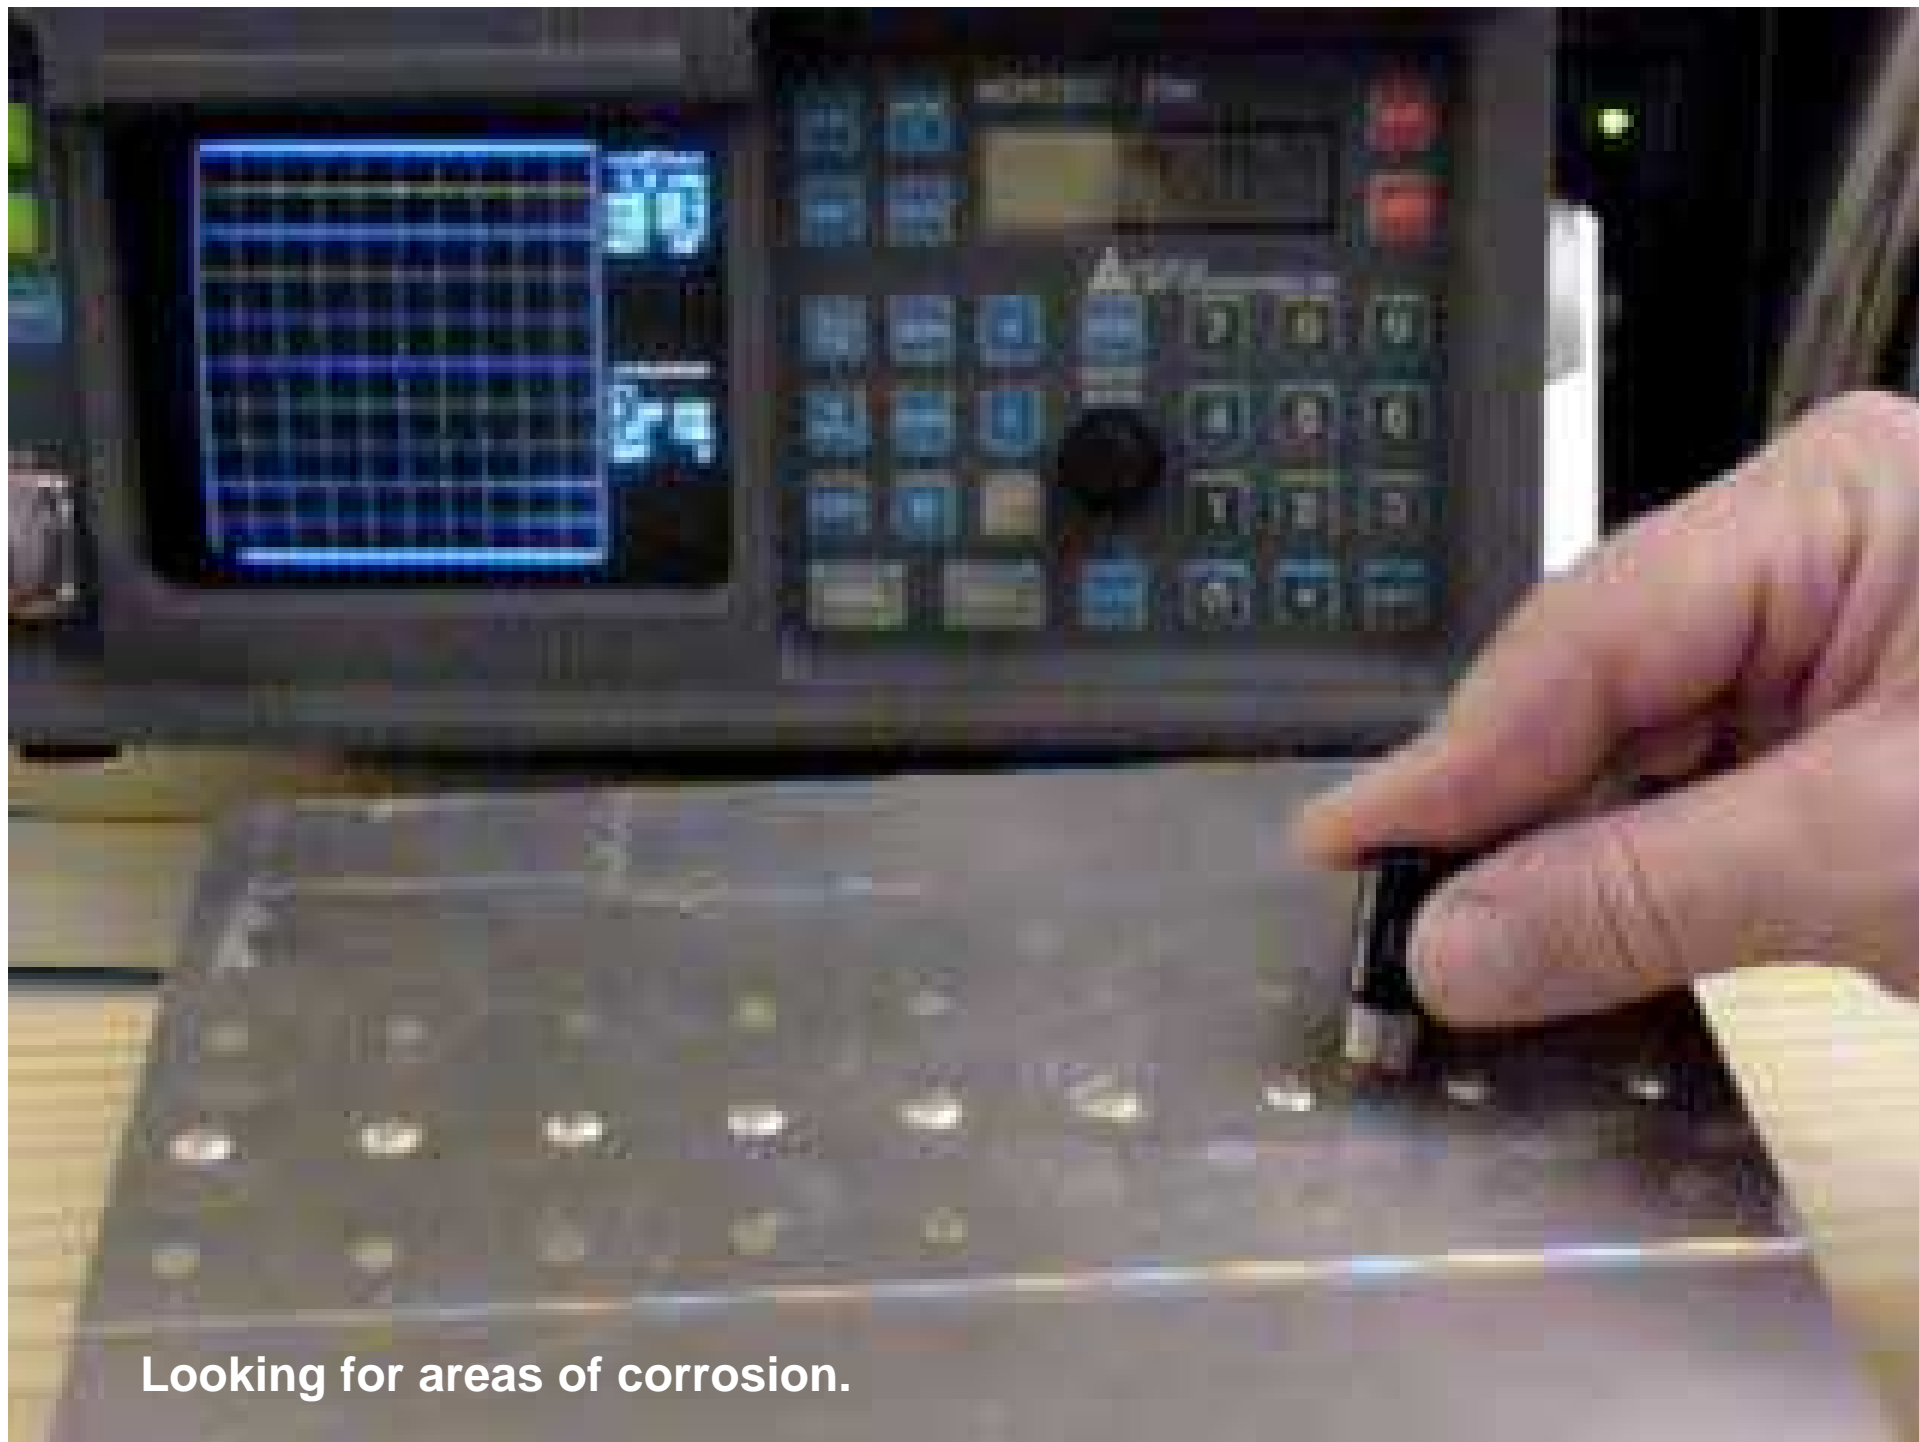
Looking for areas of corrosion.

Artificially corroded areas

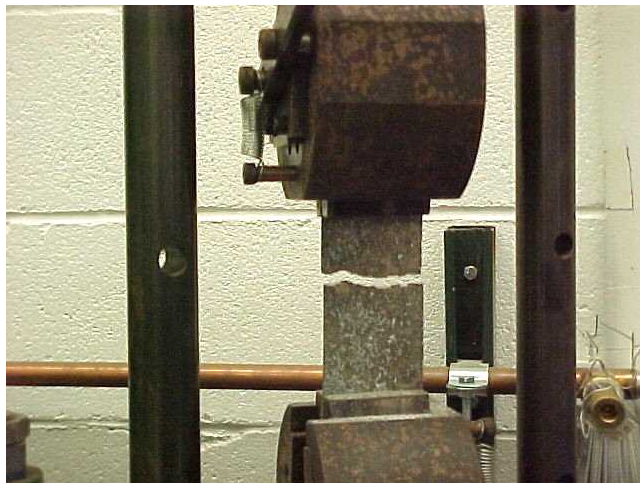
Tensile testing

- The simulated lap joints were cut in 1.5 wide pieces and tested to destruction in a tensile tester to determine how much strength was lost due to corrosion damage.
