Classroom Integration of a Construction Case Study Using Active Learning

Robert L. Mokwa, P.E., Associated Professor, Montana State University, Bozeman, Montana, USA,
rmokwa@ce.montana.edu

Abstract — A group of homeowners in a residential subdivision reported extensive settlement damage approximately two weeks after the groundwater in the vicinity of the subdivision was lowered during the installation of a 27-inch-diameter sanitary sewer main with an invert elevation about 19 ft below existing grade. Groundwater was lowered 12 ft during construction, down to a depth of 23 ft below existing grade. A lawsuit was filed by private homeowners against the general contractor, city municipality, engineering design firm, and geotechnical engineering firm as a result of alleged damages to residence structures. The interesting ramifications of this case are organized into a hands-on active learning exercise for a senior-level civil engineering course. This paper illustrates how complex technical issues can be organized and used as a valuable case study for university students to learn about the legal process of construction claims and the consequences of overlooking or misinterpreting techn

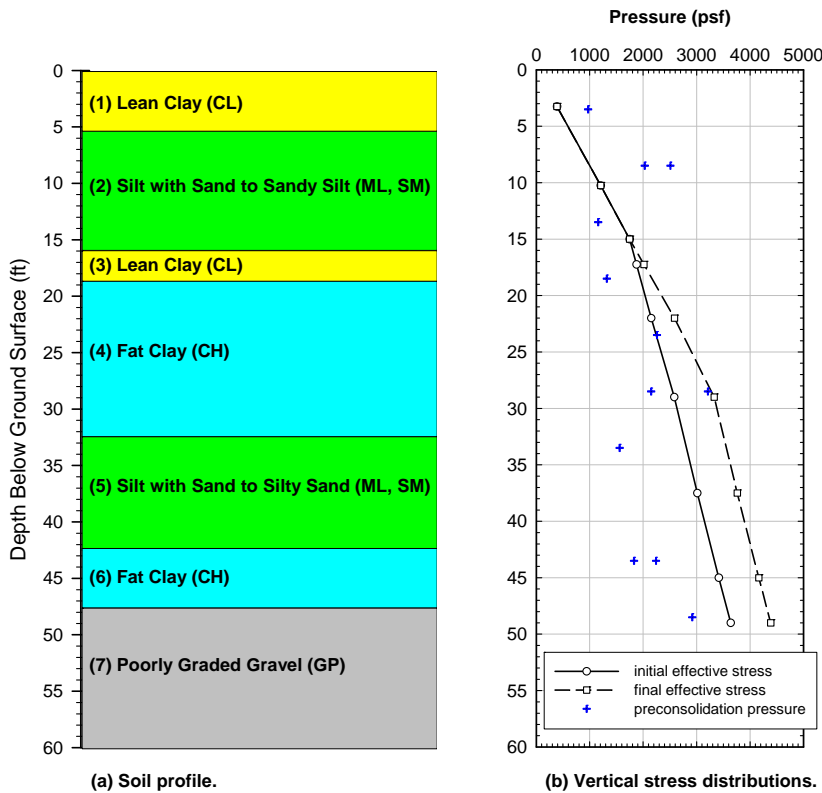
FIGURE 2. REPRESENTATIVE SOIL MODEL FOR SETTLEMENT ANALYSES

The heterogeneous soils at the site exhibit the typical randomness of alluvial soils that were transported and deposited in a flowing water environment. The simple representative soil model shown in Figure 2a was developed using test data and boring logs from geotechnical and hydrological reports that were prepared for this case. The vertical pressure distribution shown in Figure 2b was calculated using measured soil unit weights and water contents. The change in vertical stress ($\Delta\sigma_v$) is based on a 12 ft drop in groundwater at the subject property as a result of construction dewatering. The calculated final vertical stress, during drawdown, is shown as a dashed line in Figure 2b. This information was used in the consolidations analysis discussed in the next section.

A consolidation analysis was conducted using laboratory test results generated during the post-construction investigation in conjunction with the subsurface model shown in Figure 2. A computer program that uses a numerical analysis procedure was employed to calculate the magnitude and rate of consolidation settlement. Conventional Terzaghi consolidation equations were used to determine the magnitude of the ultimate consolidation settlement, after the excess pore pressures are dissipated. A finite difference approximation was used to calculate the rate of consolidation settlement and the rate of dissipation of excess pore pressures. Time rate values of soil consolidation are represented by the coefficient of consolidation, c_v , which are determined from laboratory consolidation tests. The available geotechnical data (including both consolidation and strength tests) indicate the soil deposit is normally consolidated. Using measured data from the defendant's geotechnical report, the calculated primary consolidation settlement amounts range from about 3 to 3.5 inches, as shown in Figure 3. The solid line in Figure 3 was calculated using a constant groundwater drawdown level of 12 ft, while the dashed line was calculated using the drawdown and recovery curve obtained from a dewatering test adjacent to the site. The magnitudes of settlement shown in Figure 3 are consistent with the settlement damage that was observed and documented at the residence.

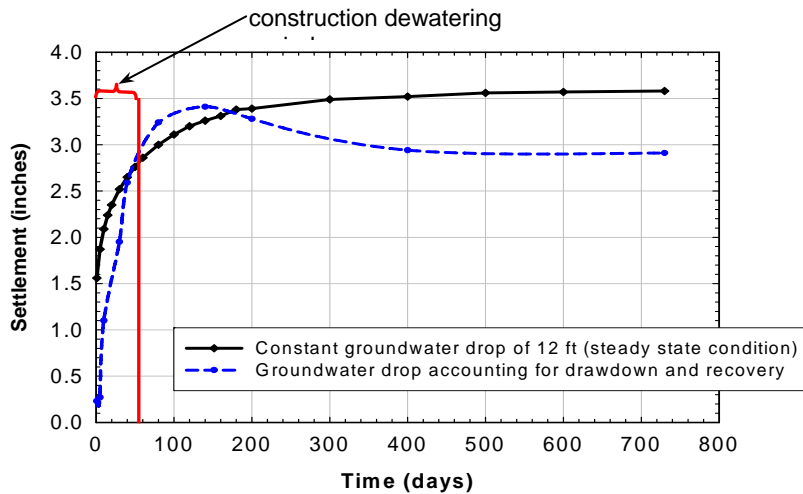
FIGURE 3. CALCULATED SETTLEMENT ASSUMING SOIL IS NORMALLY CONSOLIDATED

A report produced by the defendants presents a calculated settlement estimate approximately 75% less than the amount shown in Figure 3. The discrepancy is believed to occur in the assumptions used to evaluate the data and inconsistencies in the data itself. As with most analyses involving the prediction of soil response, there is seldom a single “correct” answer, but rather a predictive range or probable outcome. Variability introduced in calculations as a result of inaccurate assumptions or erroneous data can decrease the reliability and precision of calculated settlements. The following section further explores Potential reasons behind the apparent discrepancies in calculated settlements include assumptions regarding in-situ physical conditions, both past and present, and inaccuracies in soil test data.

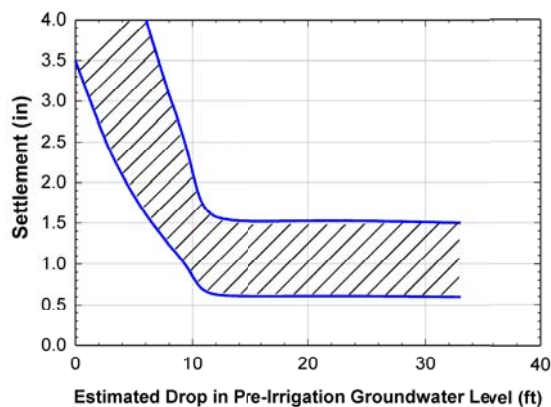
FIGURE 5. VARIATION IN CALCULATED SETTLEMENT AS A FUNCTION OF HISTORIC GROUNDWATER LEVELS

Figure 5 shows the variation in calculated settlement in relation to the assumed historic water level. Uncertainty in the settlement prediction increases as additional variables are examined. In this case, the assumption regarding historic water levels is superimposed with the error factor in the C_r soil parameter. Considering these two parameters, the variability in the settlement prediction (or margin of error) now increases from 1.2 in to 3.4 in. The high end of this range corresponds to a condition in which the pre-irrigation groundwater level is similar to the current groundwater level, in which case the soil deposit would be normally consolidated.
